Roman Stone Monuments from North Dobruja, Romania: digital survey and historical-architectural interpretation of the Halmyris fortification

Cristina-Georgeta ALEXANDRESCU, Institutul de Arheologie Vasile Parvan, Romania

CHNT Reference: Alexandrescu, C-G. (2021). 'Roman Stone Monuments from North Dobruja, Romania: digital survey and historical-architectural interpretation of the Halmyris fortification', in CHNT – ICOMOS Editorial board. *Proceedings of the 26th International Conference on Cultural Heritage and New Technologies*. Heidelberg: Propylaeum.

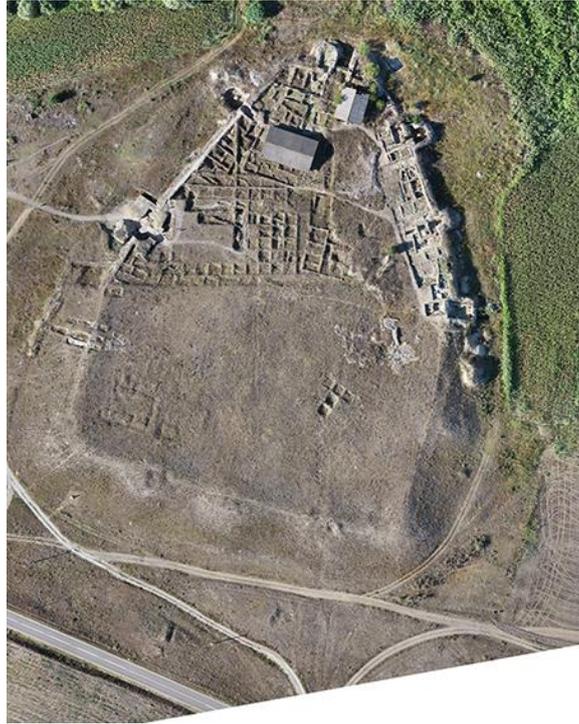
Fig. 1. Halmyris fortification, Murighiol, Tulcea county, Romania (© C.-G. Alexandrescu).
