S. Johannes in Jerusalem Church: a disclosed mystery?

Analysis of constructive technology for the knowledge of the monument

Proceedings of the 19th International Conference on Cultural Heritage and New Technologies 2014 (CHNT 19, 2014)

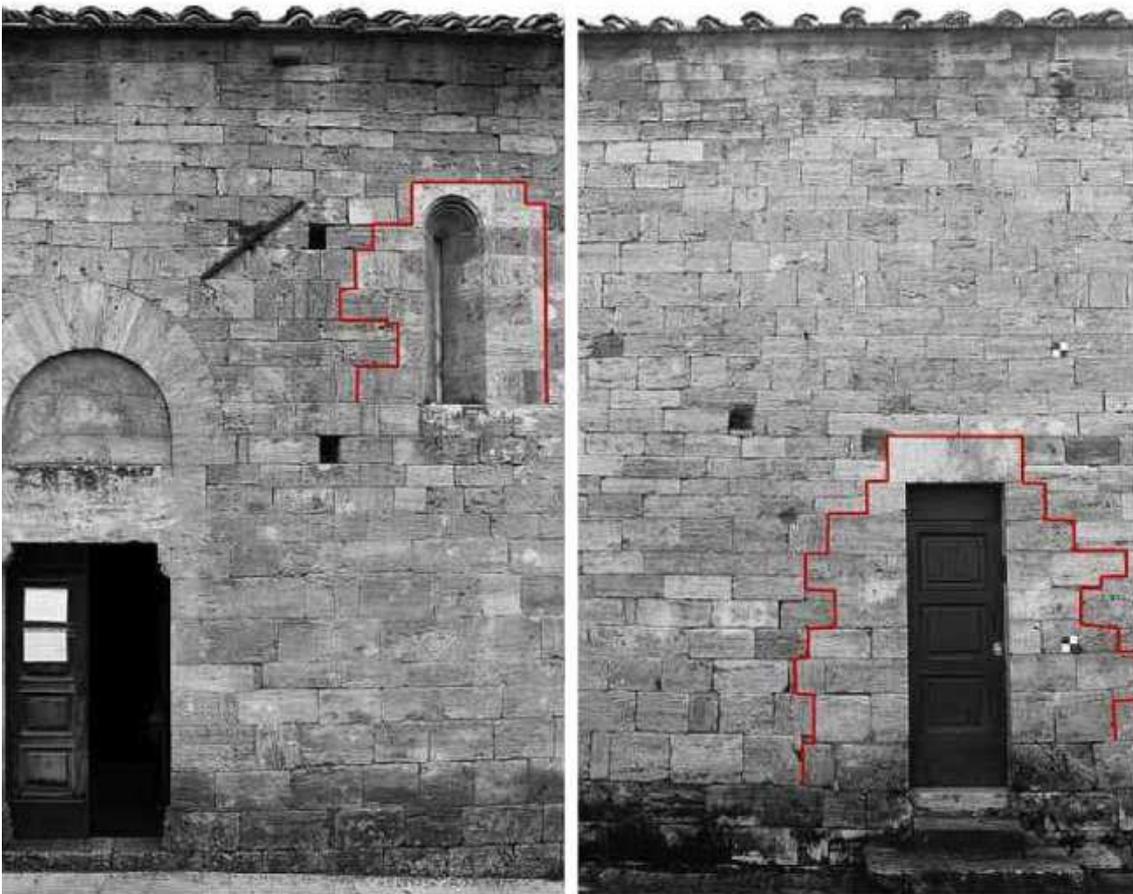
Fig. 3 – Discontinuity of the rows: later interventions (Copyright: Andrea Sichi, Carolina Rosini)

The church is characterized by rubble masonry with travertine facings; the wall thickness is 75 cm. The rows have varying heights and are regular along the whole length of the fronts; this regularity is interrupted only where interventions not coeval with the construction of the church have modified the original wall: the single-lancet window on the South-Est wall and the access doorway to presbytery on the North-West wall (Fig. 3). Moreover, according to a widespread constructional praxis, the corners are strengthened by implementation of larger ashlar that, consequently, alter the continuity of the rows (Fig. 4).

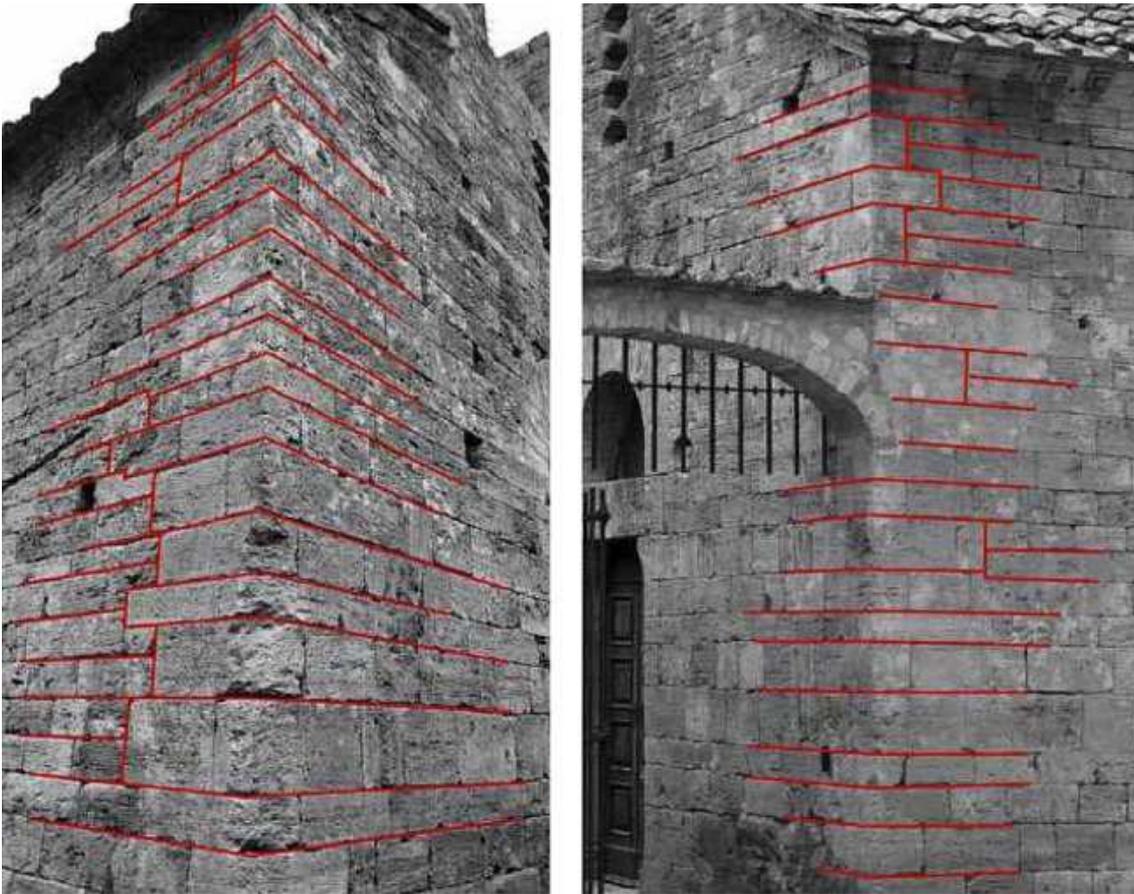
Fig. 4 – Discontinuity of the rows: corners (Copyright: Andrea Sichi, Carolina Rosini)

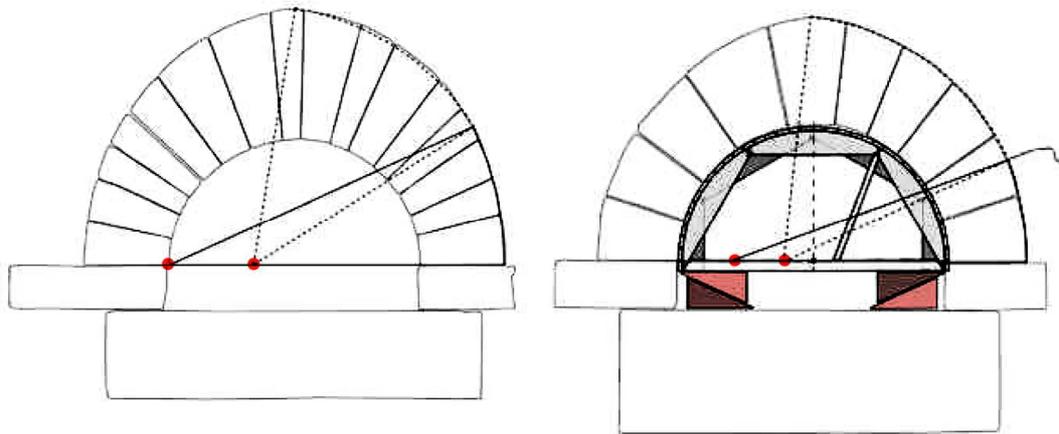
These devices consist of a double pointed arch in the extrados and a round arch in the intrados. The centers of the arches are located on the skewback which is distanced of a row from the lintel; this formal solution is nothing but the result of constructive practice: in order to be removed at the end of construction, the centrings used for the construction of the arches had to be based on wedges which determined the need to insert an additional row, between the lintel and the skewback.

Fig. 5 – Archivolts: centers and hypothesis of centring (Copyright: Andrea Sichi, Carolina Rosini)

Finally, we analyzed the construction technique of the archivolts, set on the lintel of the two access portals (Fig. 5).

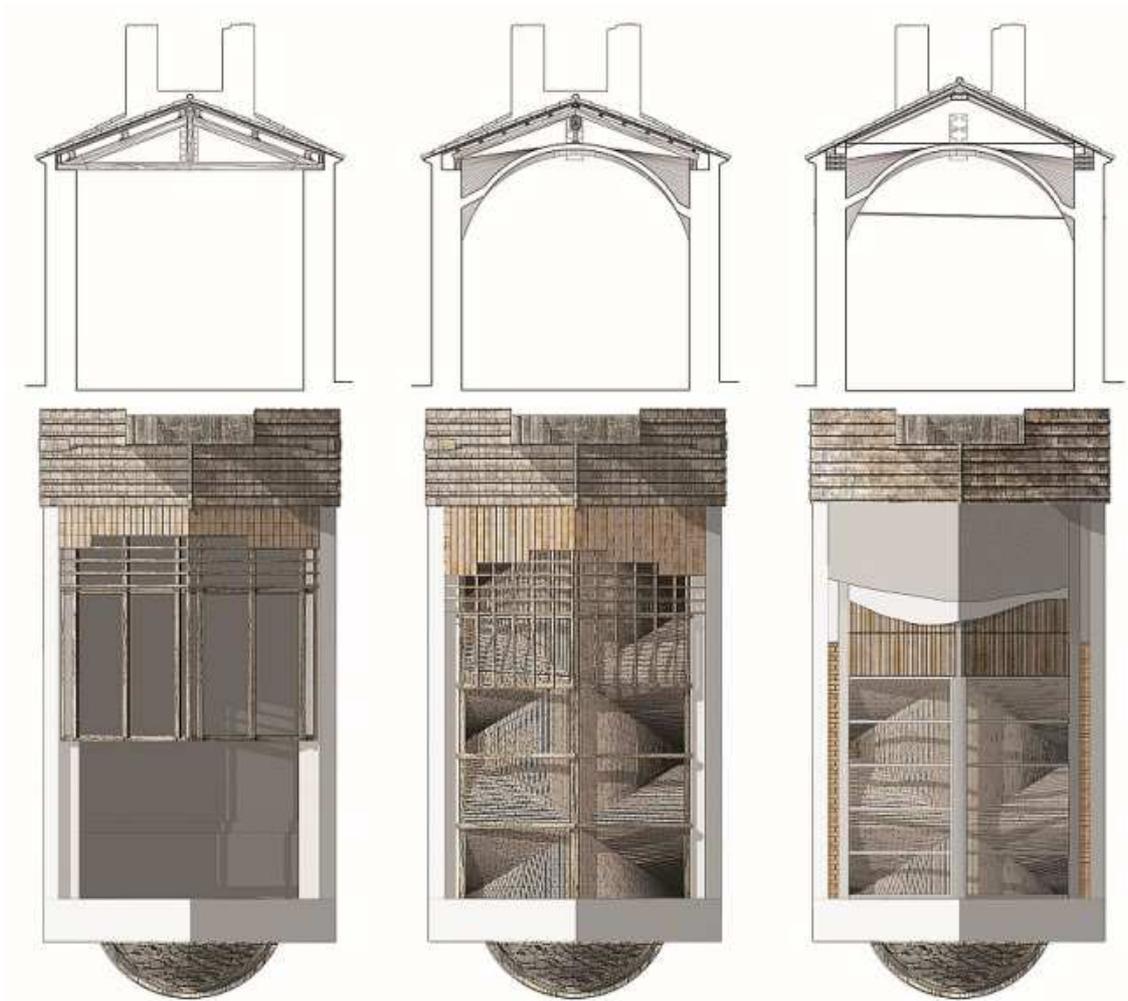
Fig. 6 – Comparison of the roofing solutions – Vertical section and top view – Left: first structure (trusses); middle: second structure (Piedmont roofing); right: existing structure (reinforced concrete structure) (Copyright: Andrea Sichi, Carolina Rosini)

Along the longitudinal sides, at the top of the masonry, there is a setback that was the plan where the first roofing solution was set (Fig. 6): a trusses system, common to minors religious architecture of Val d'Elsa. According to the dimensioning resulting from our analytical reconstruction, this structure consisted of two simple trusses, composed of tie beam, principal rafters and king post; these were enough to support the secondary frame.

For a savings in the long-term maintenance, the owners decided to replace trusses with, most likely, a Piedmont roofing (Fig. 6). By an analytical reconstruction, also for this second coverage we proceeded to the sizing of the elements. This structure, together with the vault, as will be explained later, caused a very strong thrust: that's why, at a later date, there was the implementation of two tie bars to reduce the pressure on the walls.

By the restoration of the monument, this roof was demolished and replaced with a new structure (Fig. 6): a reinforced concrete ridge beam and the secondary structure in precast joists for the support of hollow tiles; the joists are supported by two longitudinal curbs.

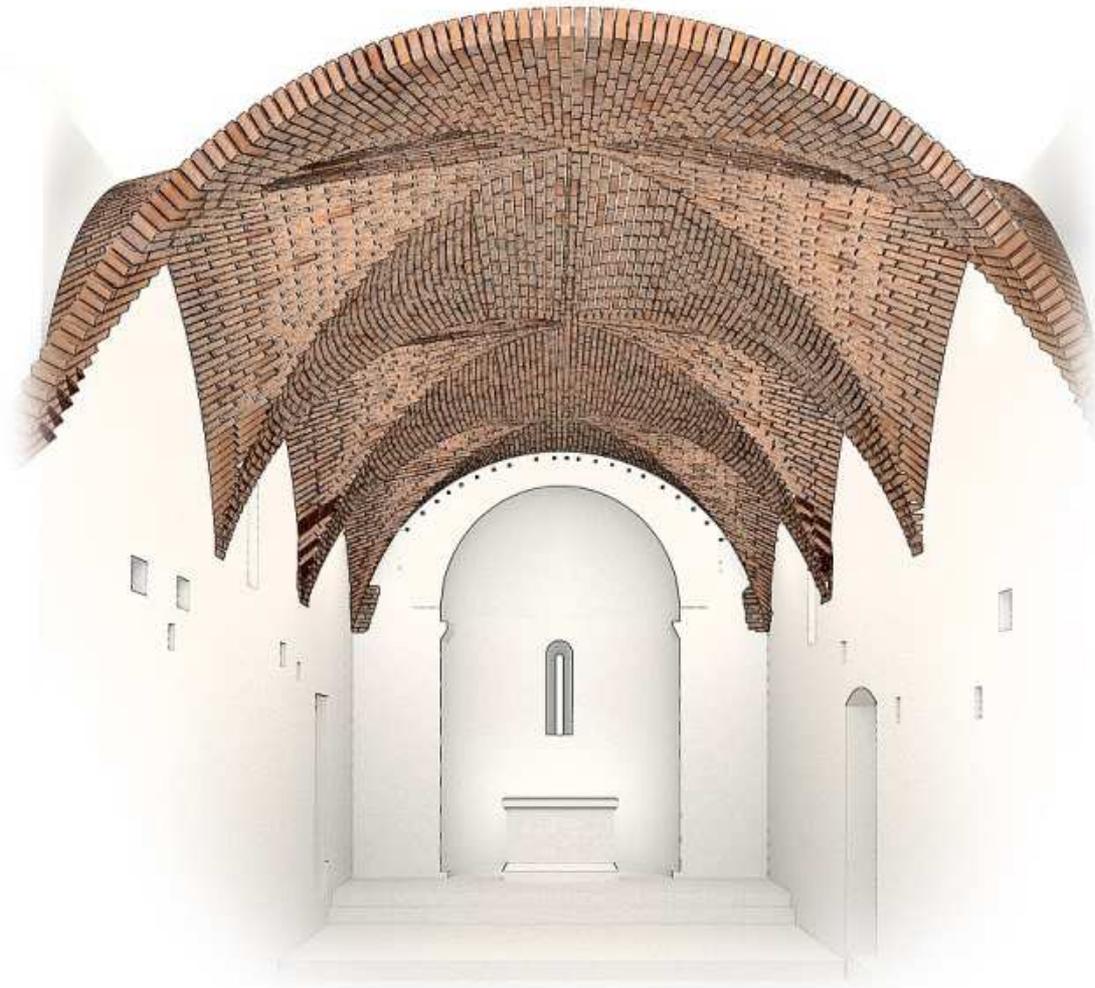
The three groined not ribbed brick vault consists of a longitudinal barrel intersected by rampant profile nails (Fig. 7); the bricks (29x15x6 cm) are laid on a side.

Fig. 7 – The three groined vault of the church (Copyright: Andrea Sichi, Carolina Rosini)

The thickness (15 cm) enables a starting point for analysis: bricks laid face-up would have generated a very light structure, an optimal requirement for a not accessible countertop device; instead, was chosen the brick laid on a side solution, strictly functional to a structural task.

Evidently, the original truss structure was exposed to fire and required too cumbersome maintenance tasks: it was decided to replace it with a Piedmont roofing. However, the 12 m distance between the walls would have caused an excessive inflection of the ridge beam. The vault would have reduced the span, providing a base for the new roof, by wooden supports fixed on the extrados; these cheap and light devices would have allowed to reduce the section of the ridge beam, costs and operations of maintenance and replacement.

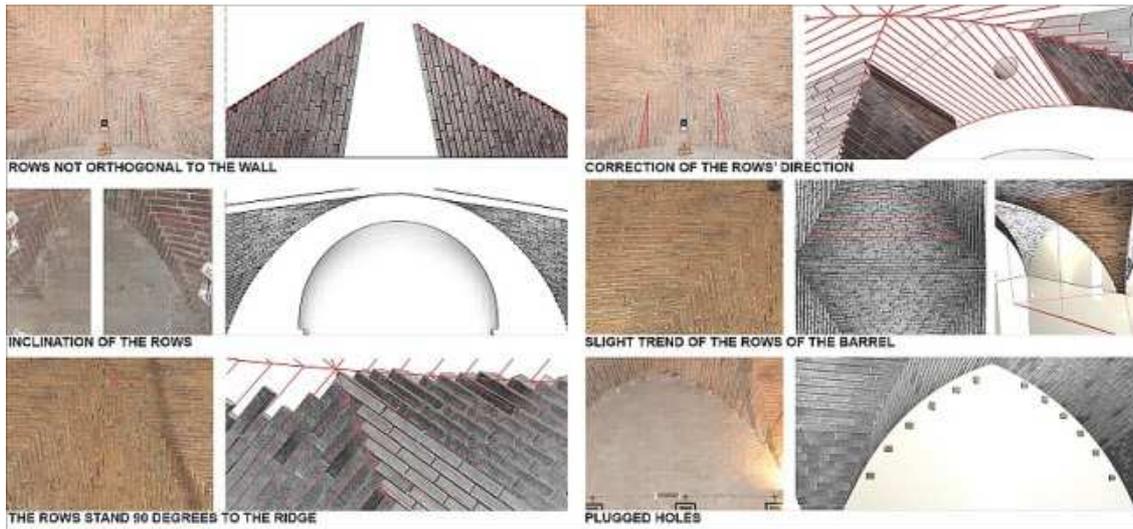
The inclined rows, the continuous corrections, the perfect joints at the intrados, the small closed holes on the church walls⁴, the slight curvature of longitudinal rows of the barrel by a top view, different geometries for each span, all this has led us to hypothesize a building technique that does not require scaffoldings and ribs, provisional structures for support and geometrical definition (Fig. 8).

Fig. 8 – Vault details (Copyright: Andrea Sichi, Carolina Rosini)

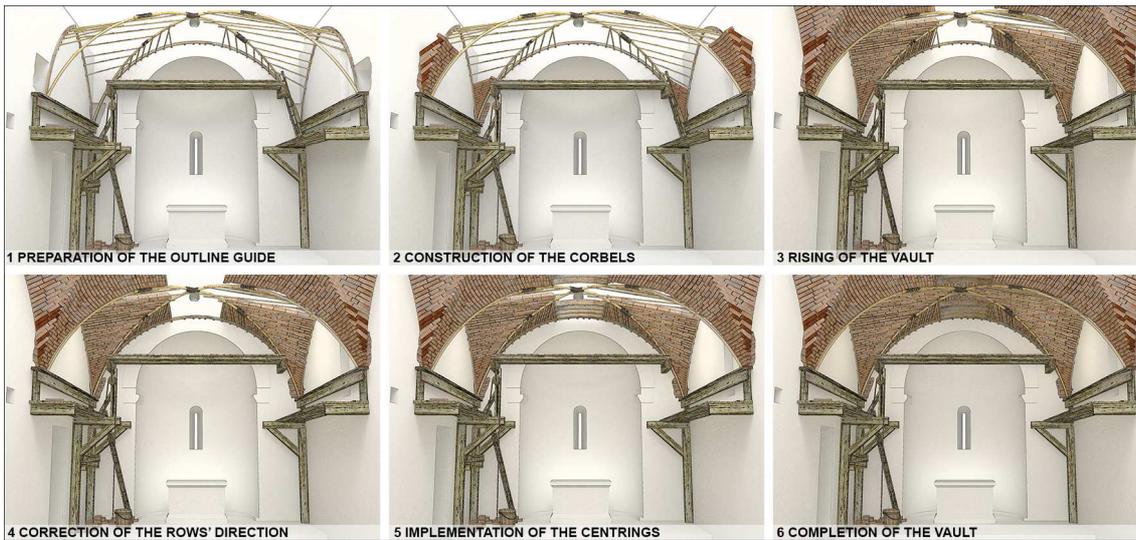
Analyzing the data, we developed the technique that would have granted this solution (Fig. 9): first through a 3D simulation, afterward through a 1:10 scale model.

Fig. 9 – Construction phases of the vault (Copyright: Andrea Sichi, Carolina Rosini)

Drawn the arc profile geometry of the groins and barrel on the walls, they built arc profiles to define the ridges, for example with simple curved river reeds⁵. The remaining portions of the vault could be defined by using a system formed by reeds which inserted into the holes described earlier, would settle on the curved reeds of the ridges. This created a “wireframe” device that was used to define the geometry of the vault to be built, a reference to allow bricklayers to visualize the direction (the set-up) to give to the bricks.

This would not solve the problem of the self-supporting; to avoid a collapse during the construction was necessary an additional device: the inclination of the brick rows. Two corresponding rows, belonging respectively to the barrel and the groin, tilted and settled at a right angle on the ridge, trigger a push force that contrasts the sinking strain by driving it on the walls. To get the right inclination, the rows (the visual reference) had to be settled into a higher section on the crest than that of the start. The 90 degrees arrangement of these rows would have facilitated the laying of the bricks, decreasing the cutting phases. The inclination of the rows, reached a certain altitude, would not have been sufficient to eliminate the weight force and the portions not yet closed would begin to collapse. To complete the vault it was necessary to change technology: little wooden shapes, pushing on the opposite portions of masonry just built, would have allowed to complete the vault. First they would have guaranteed the support to the bricks (in this phase the bricks are laid forming arches one after another, clamped comb) and, furthermore, they would have pushed on the portions of masonry stabilizing them. That's why there are corrections of the longitudinal rows near the apse.

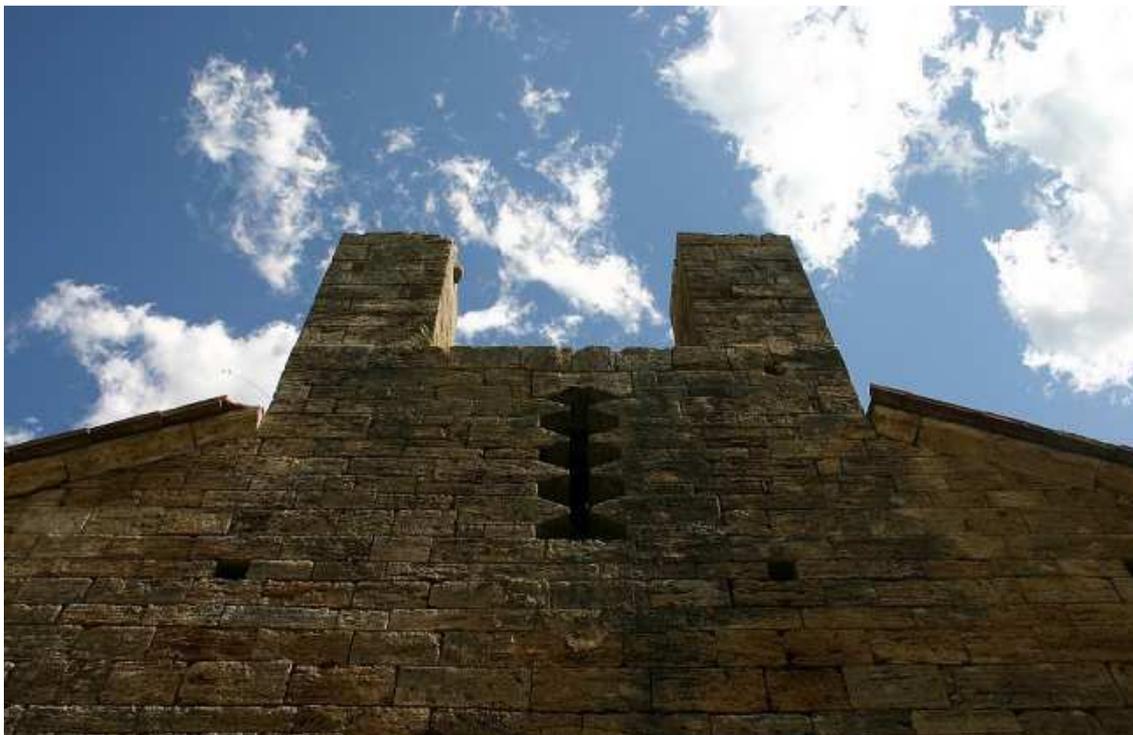
The denticular single-lancet window is unique (Fig. 10), there are no other examples known and nobody has never clarified the reason of its shape and function: our analysis has led to original outcomes.

Fig. 10 – The single-lancet window of the main front (Copyright: Andrea Sichi, Carolina Rosini)

First, by the analysis of masonry follows that the window was designed together with the rest of the church: perfect tothing between the ashlar, no solution of continuity, identical cuts and processes in relation to the adjacent stones allow us to affirm that it is not a later work.

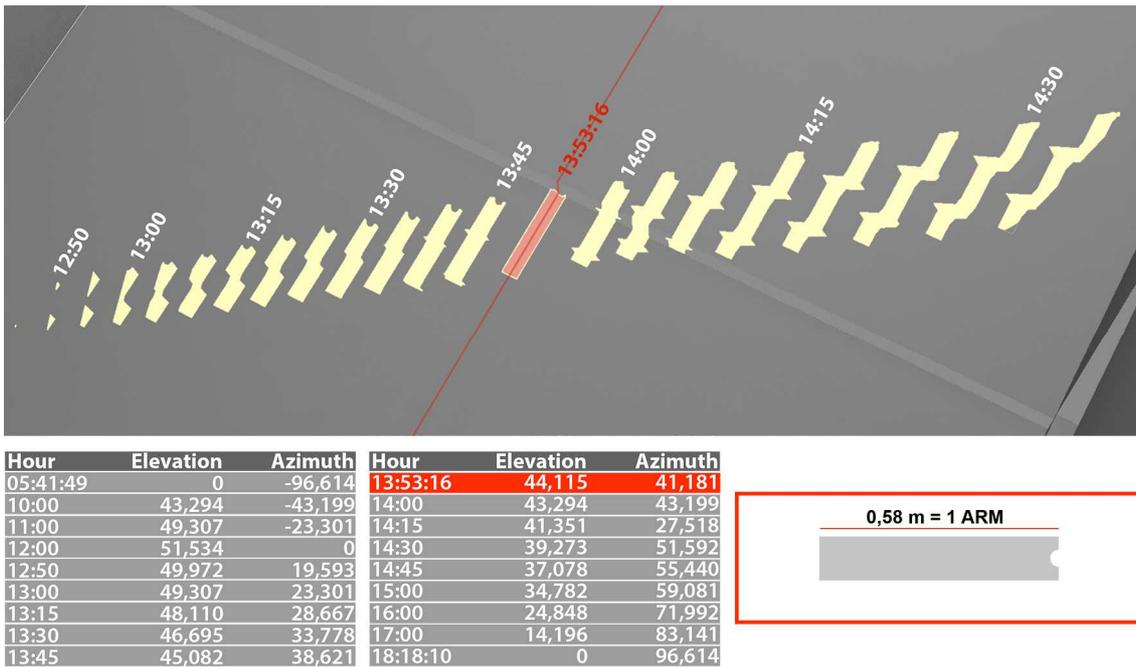
We found that the day is the 93rd, April 3, or 2 if it is a leap year. On this day, at approximately 2 pm, the projection's length is one arm⁶ and a precise point is detected: the intersection between the longitudinal axis and the step, normal to it, that separates the presbytery from assembly (Fig.11).

Fig. 11 – April 3rd: the shape of the light's projection during the day 93 (Copyright: Andrea Sichi, Carolina Rosini)

The point is simply the gnomonic projection generated by the appendage, located on the lintel of the window, to which no one had assigned a particular function so far. The architect not only wanted to find an area, but also a length and a point, on a precise day of the year⁷.
